AFWAL-TR-85-4150
Volume 2

DEVELOPMENT OF FRACTURE MECHANICS MAPS
FOR COMPOSITE MATERIALS

DFVLR - Institute for Structural Mechanics
Braunschweig, West Germany

Final Report for Period January 1982 - January 1985

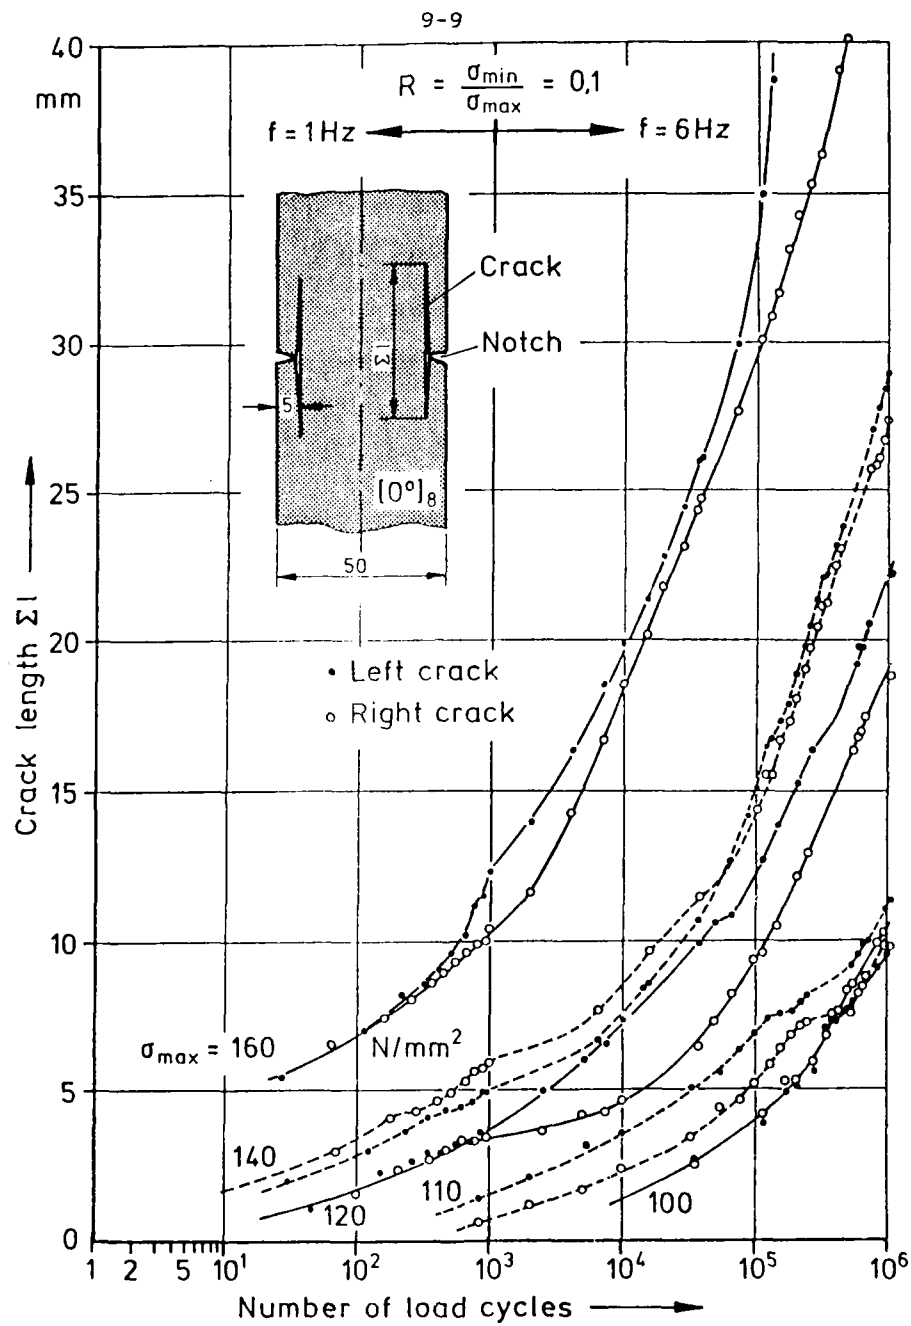
Fig. 9.1 Crack propagation in notched unidirectional CFRE-laminates under tension-tension-fatigue load.

Some of the curves in Fig. 9.1 exhibit on occasional horizontal response which is indicative of misaligned fibers acting as temporary crack stoppers.

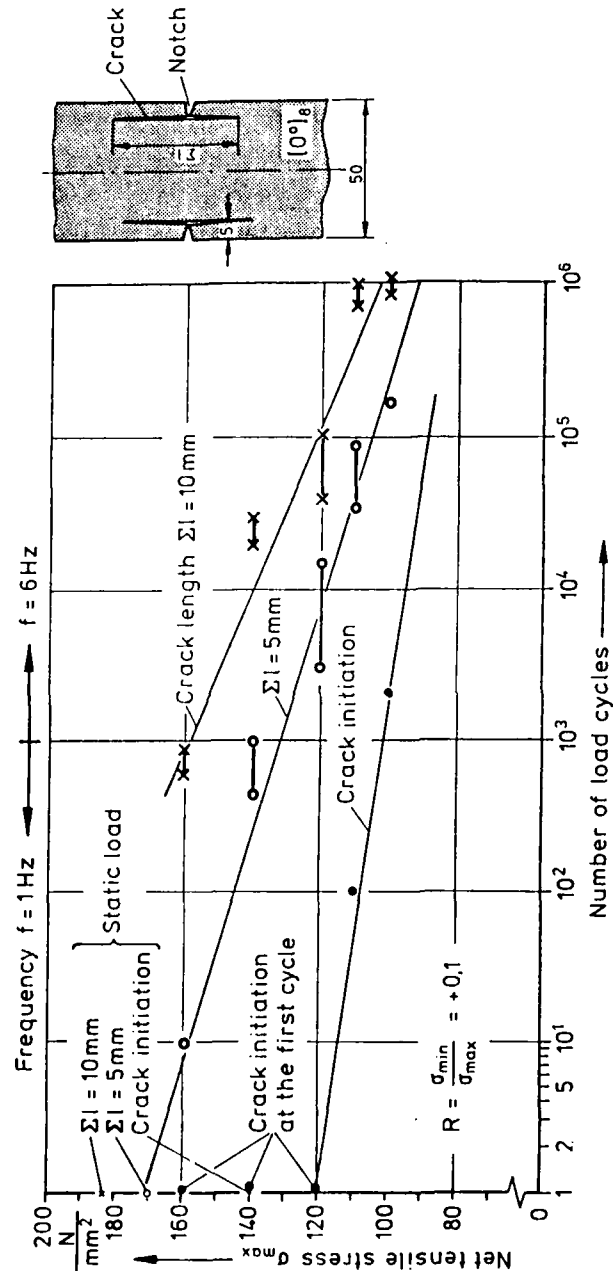
Fig. 9.2 Crack initiation and crack propagation in notched unidirectional CFRE-laminates under static and tension-tension fatigue loads.

Fig. 9.2 displays curves of equal crack length as functions of load cycles for different σ_0 . In logarithmic representation they tend to be linear for load cycles larger than 10^2 .

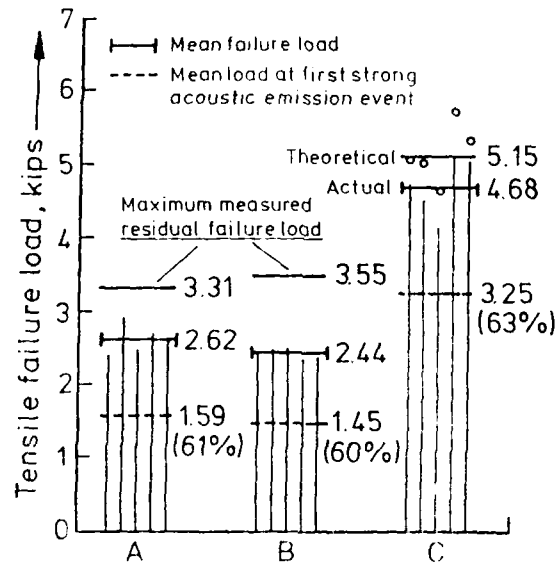
Fig. 9.3 Individual and average failure loads of A-, B- and C-type laminates.

Tensile strength tests were performed on five specimens each of notched A- and B-type laminates and of unnotched C-type laminates. The individual failure loads of the specimens and the average failure loads are represented in Fig. 9.3. The dashed horizontal lines indicate the averaged load levels at which major discontinuities in the strain-load curves, accompanied by strong acoustic emissions, occurred.

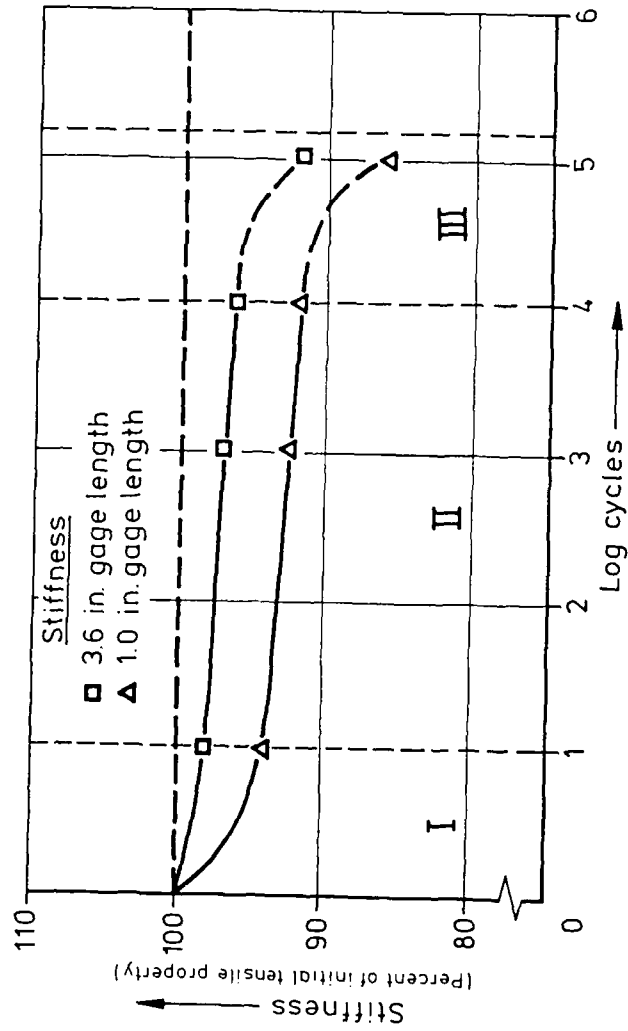
Fig. 9.6 Stiffness degradation for a B-type laminate during tension-tension fatigue loading.

Fig. 9.6 contains stiffness data for B-type laminates cycled at the 85% level. The two curves show the stiffness degradations established by displacement measurements with extensometers of 1.0 in and 3.6 in gage lengths. The stiffness changes based on the former are larger and more nearly realistic unless the damage zone spreads beyond the 1.0 in gage length.

The limits of the indicated regions I, II and III in Fig. 9.6 reflect somewhat arbitrarily transitions in the damage growth process as represented by stiffness changes. In region I, with increasing load cycles the stiffness decreases at a decreasing rate as small matrix cracks develop near the hole. In region II, the stiffness continues to degrade more or less linearly with increasing load cycles. The matrix cracks in the zero and 45-degree plies extend away from the hole while delaminations form in the region damaged by the matrix cracks. Region III begins as the rate of stiffness degradation increases. In this region, the sharp decrease in stiffness is associated with further extension of the cracks in the 45-degree plies, and the growth of the delaminations along the 45-degree matrix cracks. Early in the life of the laminate (region I) the damage is confined to the approximate zone of stress concentration around the hole. In later stages of life, the stresses around the hole are redistributed and the stress concentration around the hole is relaxed due to the growth of the damage zone away from the hole. X-ray records of damaged A- and B-type specimens showing these damage zones are presented in Fig. 9.7 and Fig. 9.8.

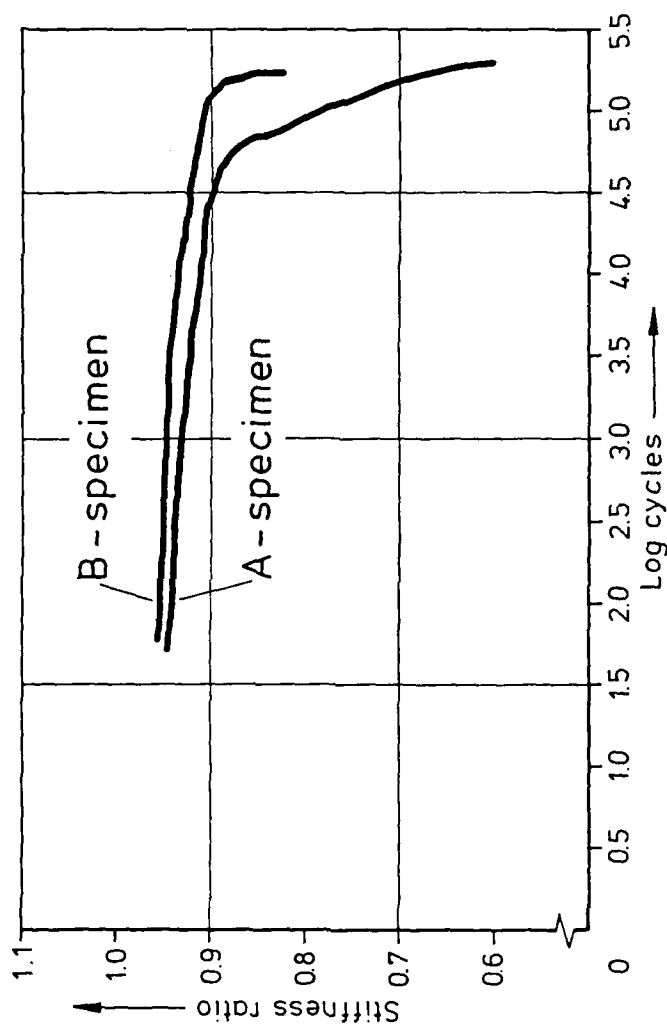
Fig. 9.9 Stiffness degradation of A- and B-type laminates during fatigue loading.

Fig. 9.9 shows regions II and III of the stiffness degradation in A- and B-type specimens during fatigue loading at 90% of static failure load. The time axis is logarithmically scaled. In this representation, region II appears as an almost linear line lead-

ing into a sharp knee which connects region II with region III. Immediately behind the knee, the degradation rate appears to be highly increased. At the end of region III, the stiffness decay accelerates again until failure. Comparing the two curves shown in Fig. 9.9, the B-type laminate shows a lower stiffness degradation before the knee, a later and more distinct formation of the knee, and a higher degradation rate after the knee than the A-laminate. The stiffness loss at the end of the fatigue life is 18 percent for the B-type and 40 percent for the A-type specimen.

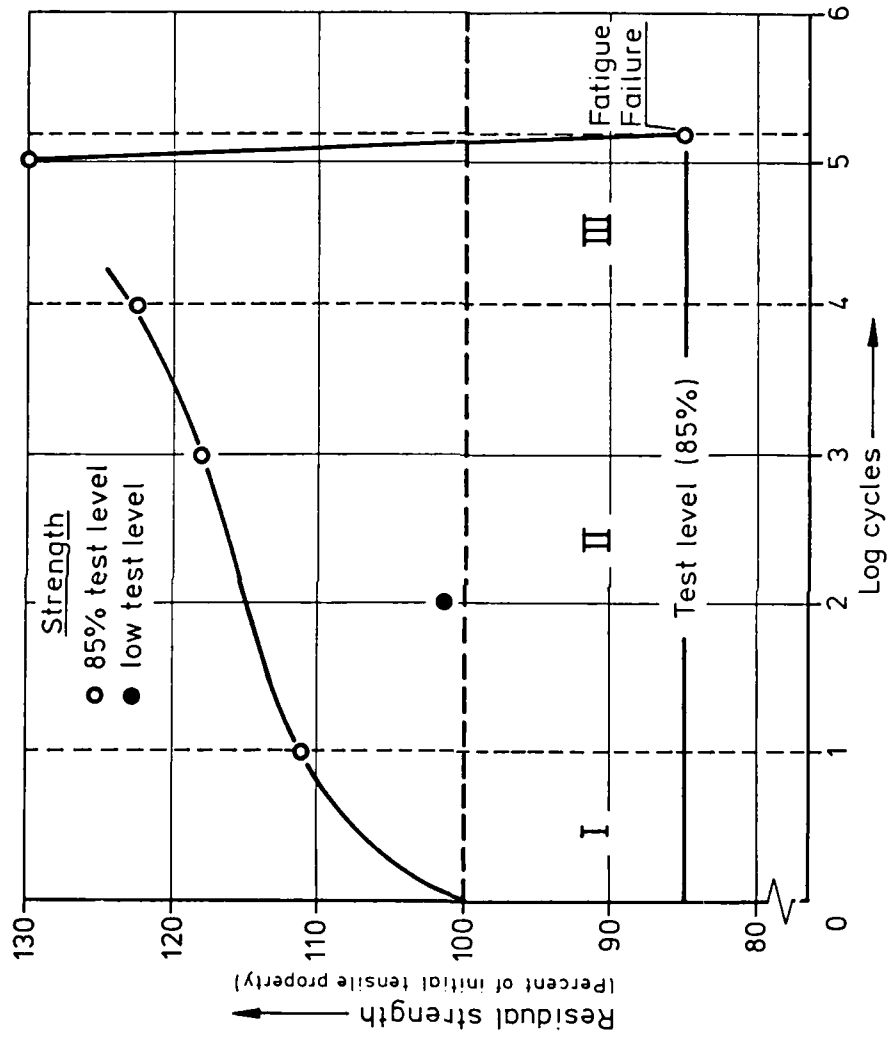
Fig. 9.10 Residual strength of B-type specimens.

A number of the cyclic tests was interrupted at various loading stages for the nondestructive inspection of the damage zone and for residual strength measurements. This series of tests provided the characteristic curves of the change in residual strength throughout the loading history given in Fig. 9.10 for a load level of 85% in the B-type laminates. It is apparent that the actual strength increase depends on the cyclic stress level such that higher stress levels produce slightly higher strength increases than lower stress levels.

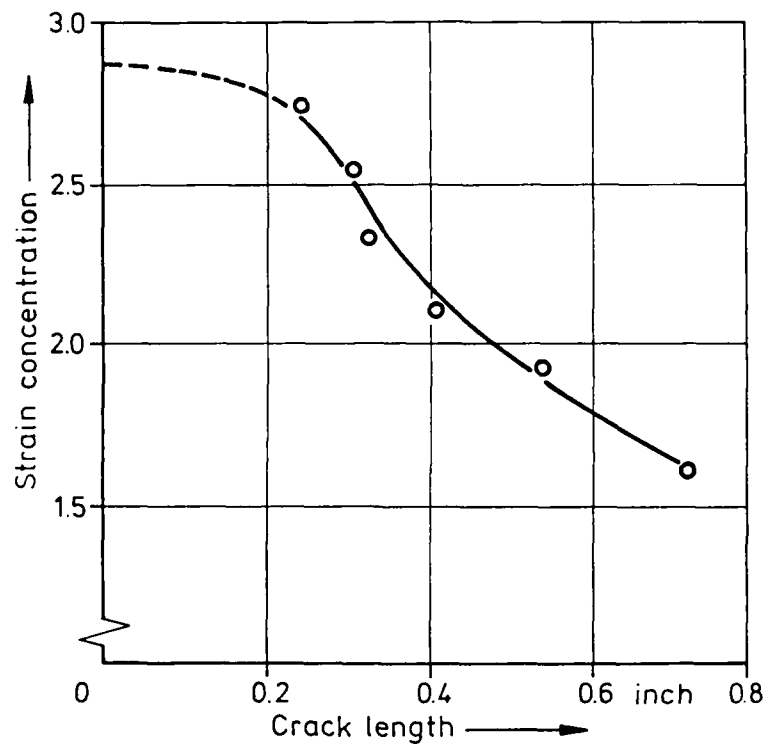
Fig. 9.13 Average strain concentration as a function of length of tangential-0-degree cracks.

Fig. 9.13 represents the average strain concentrations as a function of the length of the tangent cracks at various fatigue stages for an A-type specimen. After 6×10^5 cycles, which correspond to approximately 50% of the expected lifetime, the strain concentration is reduced to $K = 1.46$.

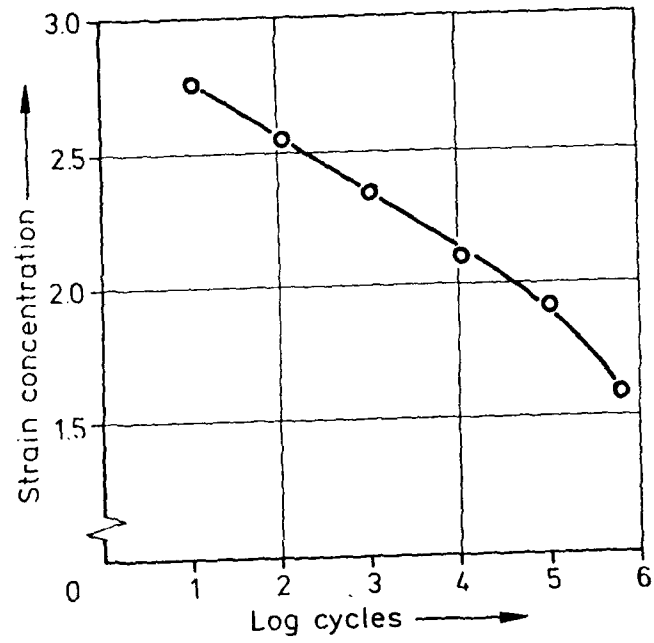
Fig. 9.14 Strain concentration versus number of cycles.

Fig. 9.14 shows the decrease of strain concentrations versus the logarithmically scaled number of cycles. The rate of decrease is very high during the first cycles of fatigue loading. Recalling that the rate of increase of residual strength of both laminates is also very high at the beginning of the fatigue life, it seems likely that the tangent 0-degree cracks are a main factor influencing residual strength.

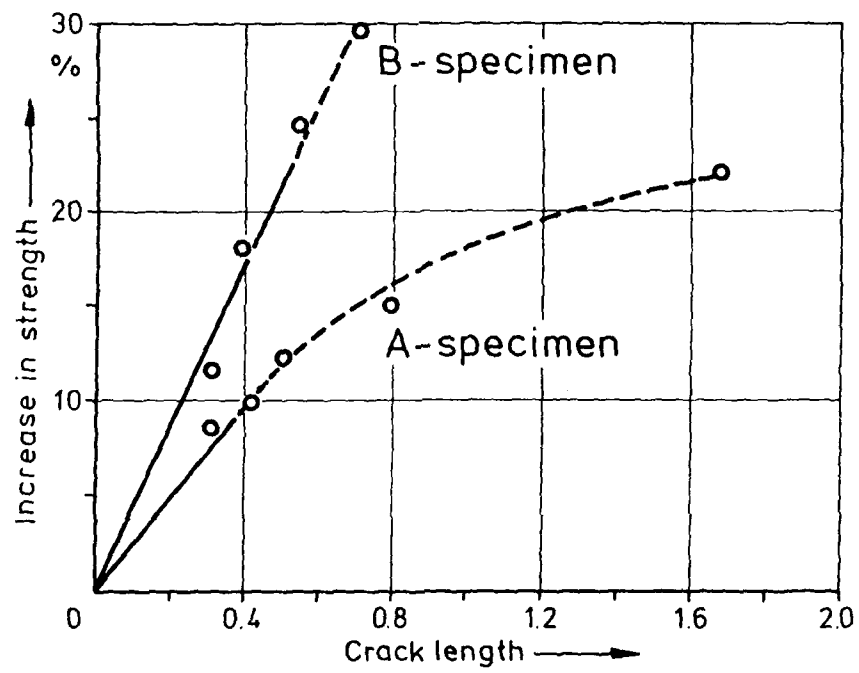
Fig. 9.15 Strength as a function of the length of tangential-0 degree cracks.

Fig. 9.15 finally shows the results of two strength tests performed on an A-type specimen and on a B-type specimen versus the length of the tangential cracks obtained from X-ray photos taken after applying the fatigue load. Cracks of equal length in A- and B-type specimen seem to influence their strength increases differently. A linear curve fit of the data points indicates strength increases of 23% for the A-type laminat and of 44% for the B-type laminate.

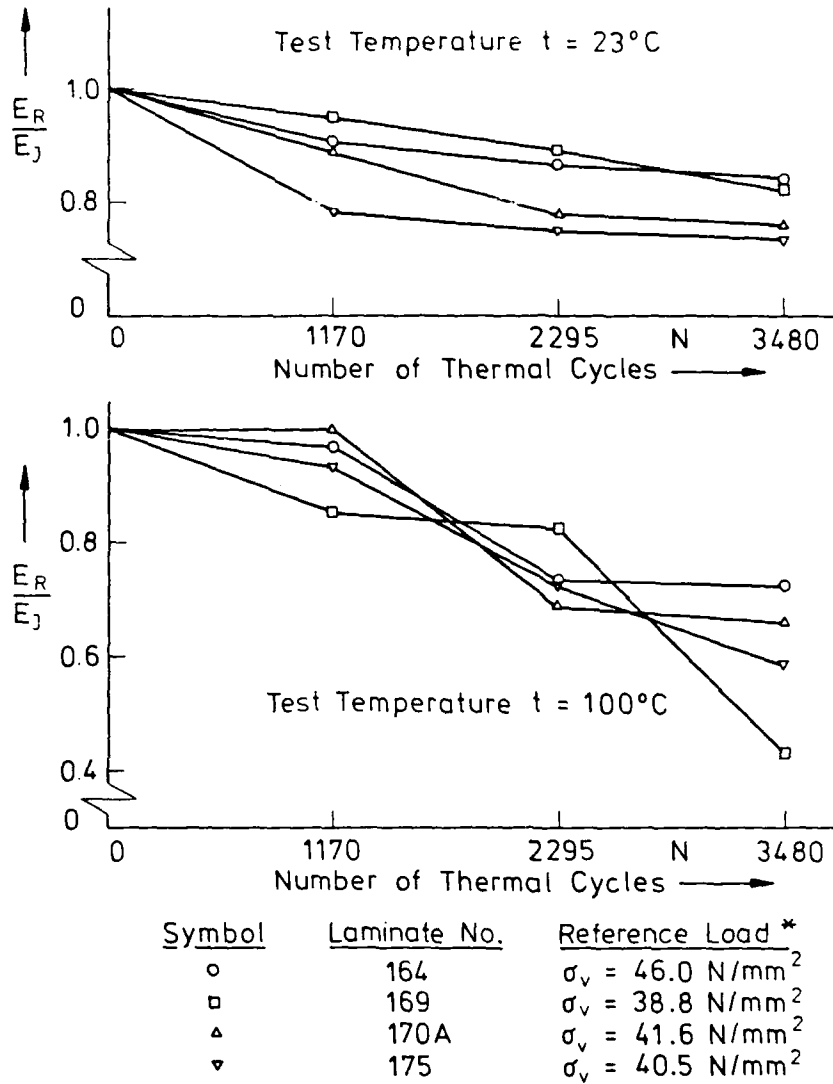
* Reference Load was Defined to be the Load Resulting in an Elongation of 2mm/m of a Virginal Specimen at Room Temperature

Fig. 10.9 Stiffness degradation due to thermal cycling.

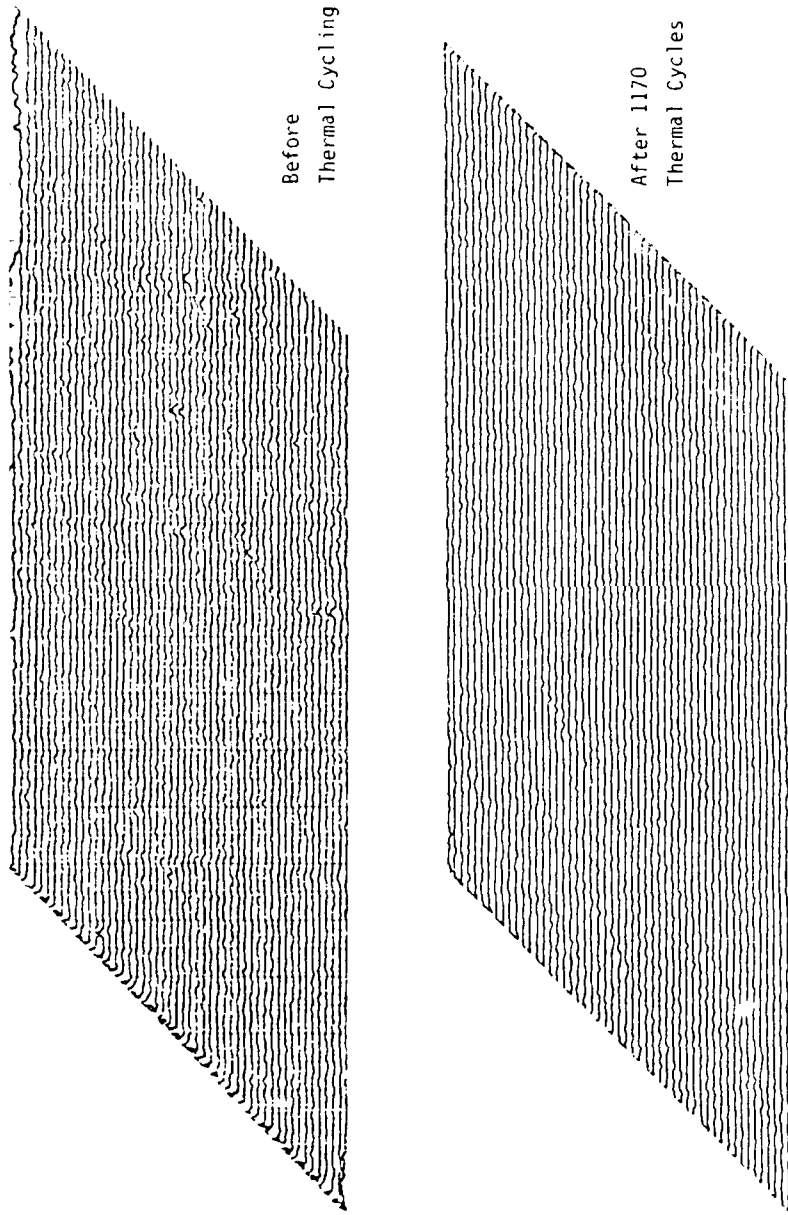
Fig. 10.13 Amplitude scans of a 914C/T300 laminate before and after thermal cycling.

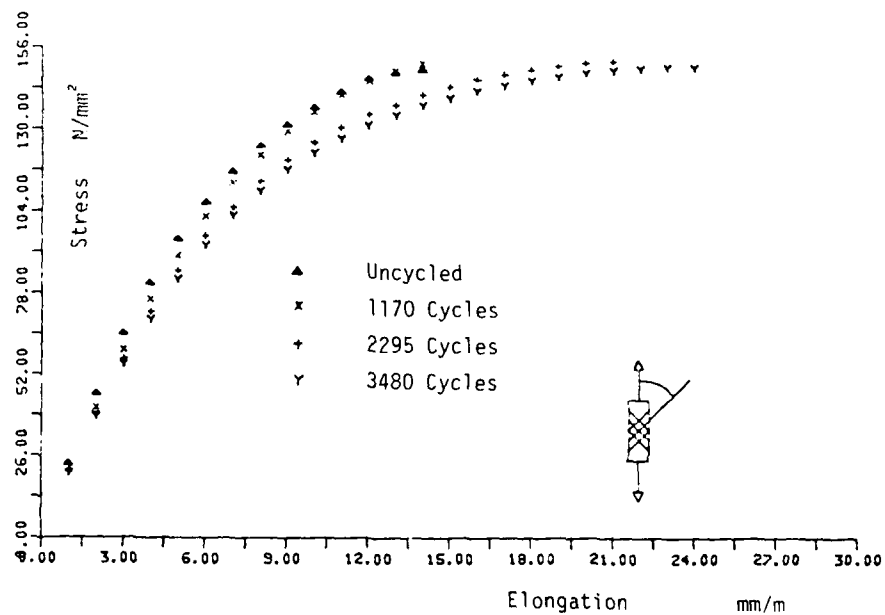
Fig. 10.16 Stress-strain curves for 914C/T300 laminate at 23°C
(Average values of 3 tests).

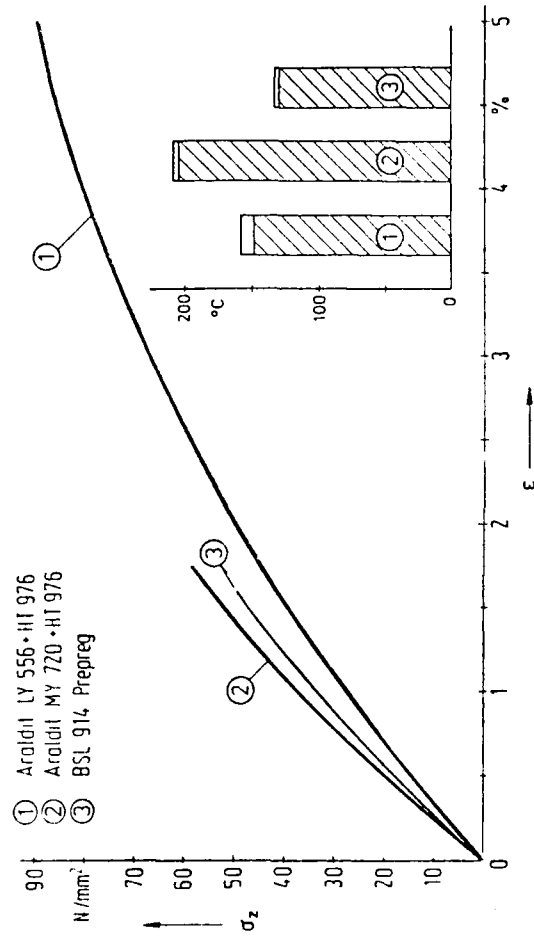
Fig. 11.1 Stress/strain plots and thermal stability of three epoxy resin types.

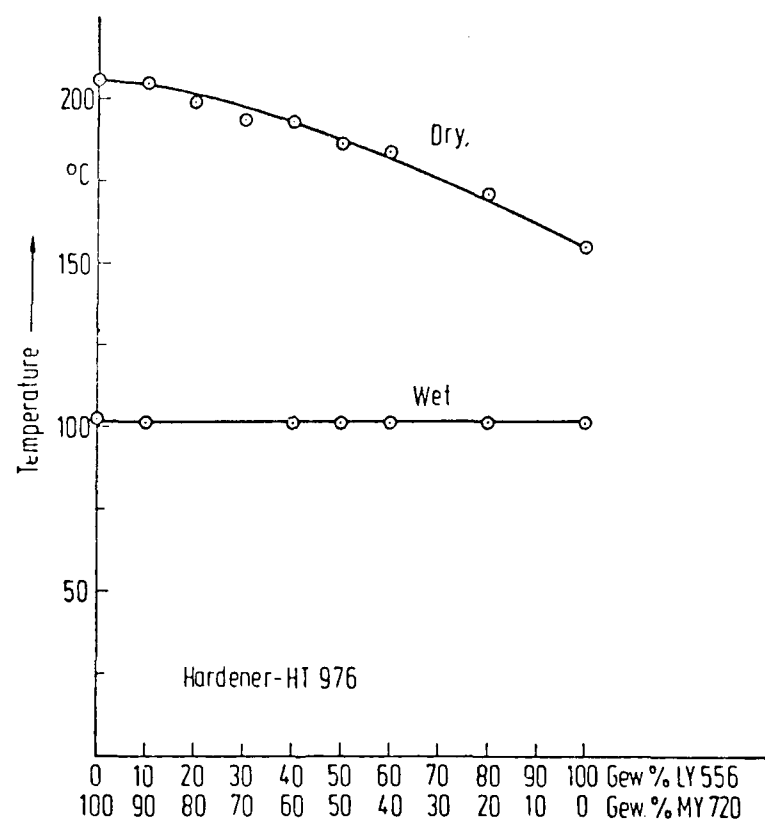
Fig. 11.3 Temperature of thermal stability of mixtures with MY 720 and LY 556 resins (DIN 53 458).

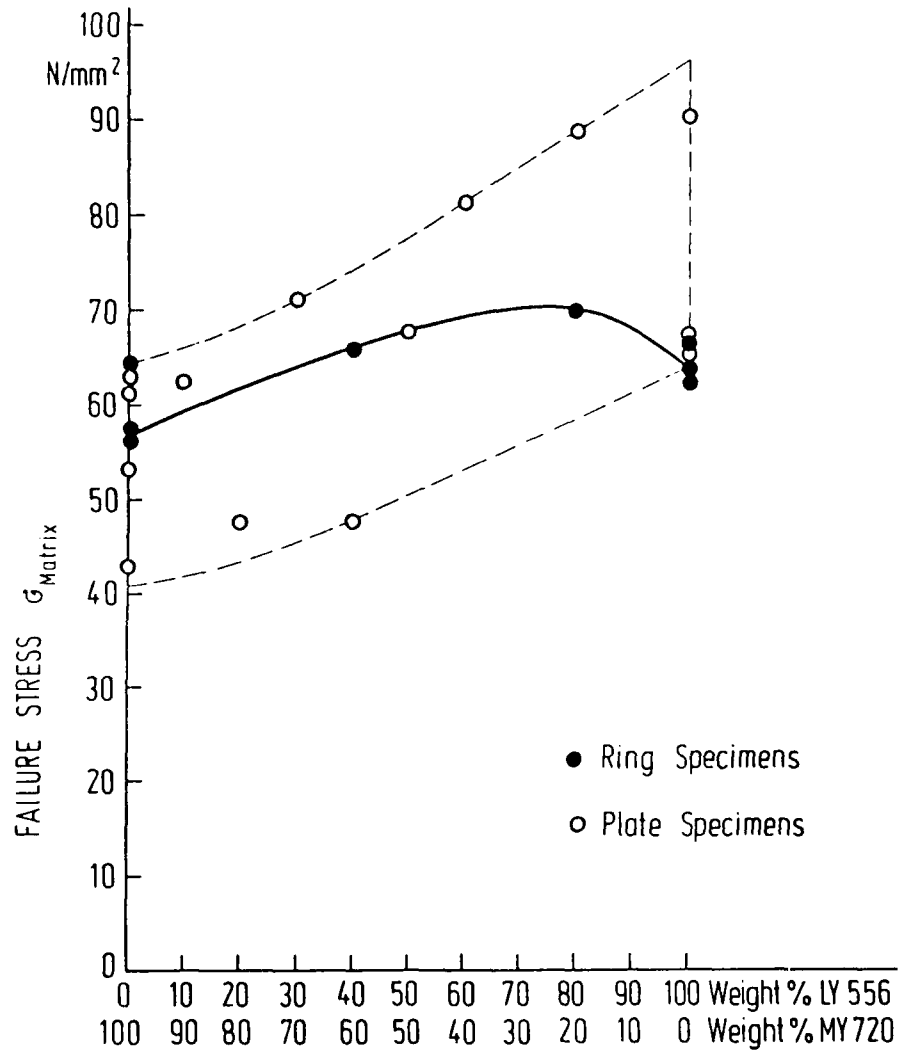
Fig. 11.4 Matrix failure stress depending on mixture ratio of the two resin components LY 556 and MY 720.

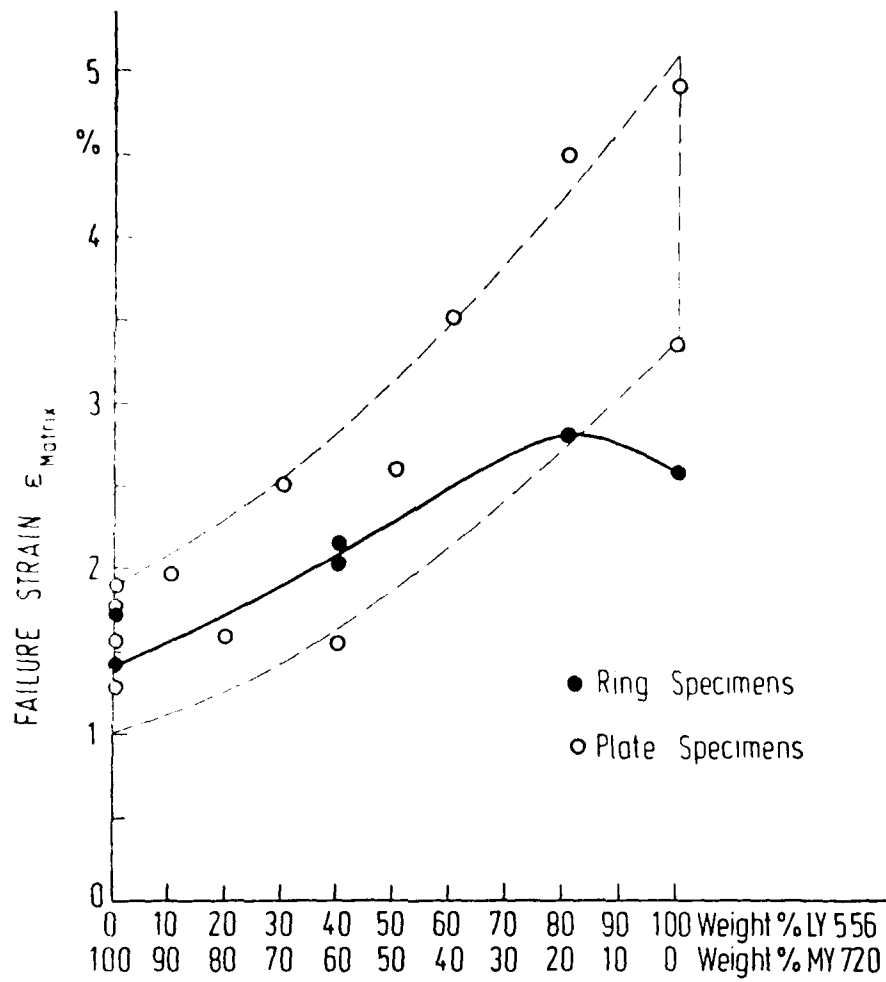
Fig. 11.5 Matrix failure strain depending on mixture ratio of the two resin components LY 556 and MY 720.

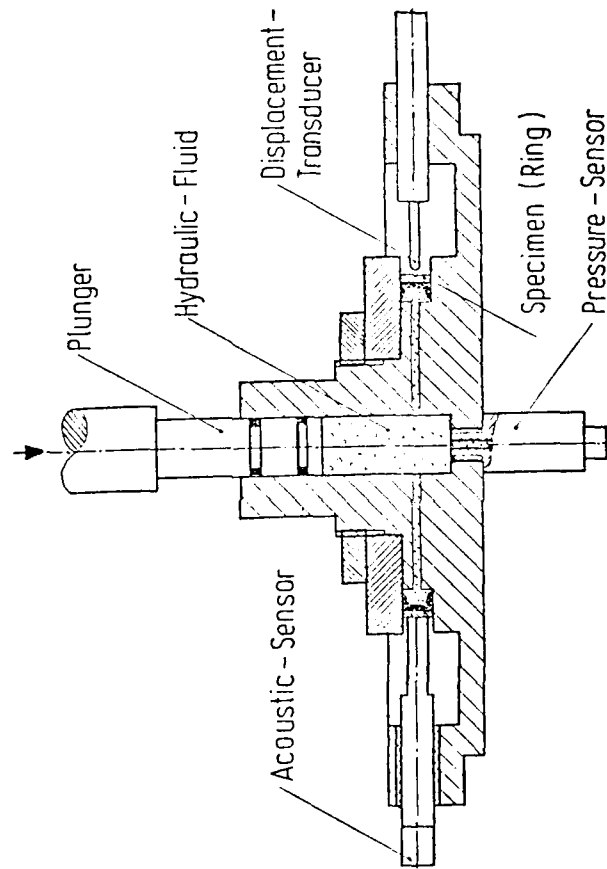
Fig. 11.6 Testing installation for NOL-ring loading

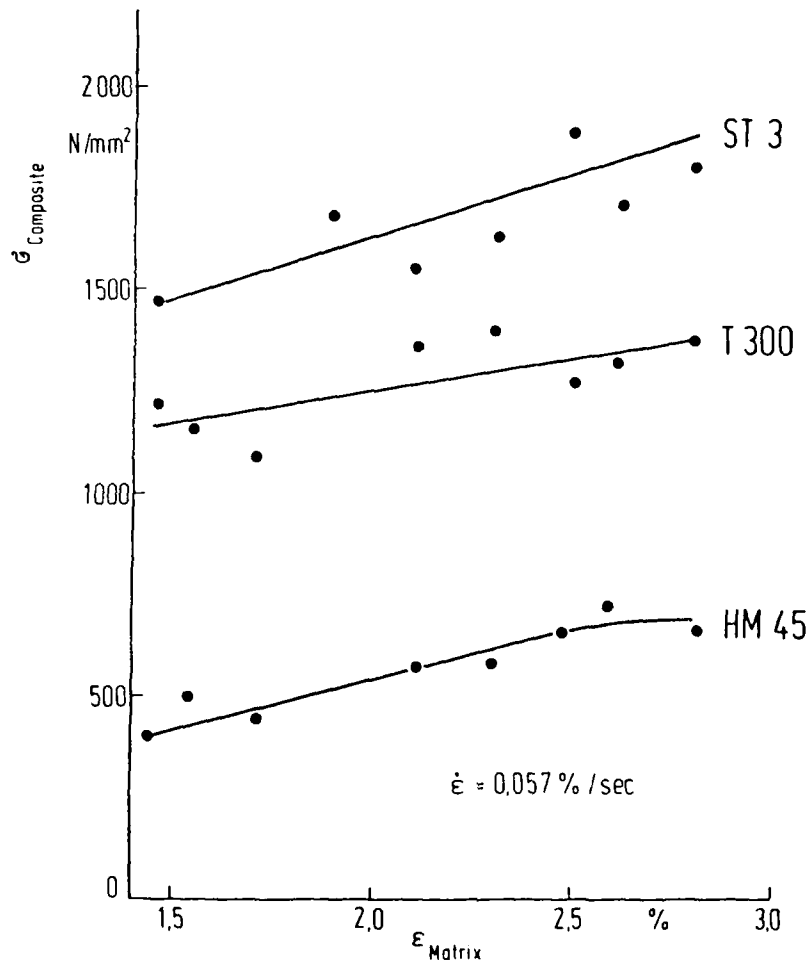
Fig. 11.11 Failure stress of CFRP-rings at a strain rate of 0.057 %/sec vs. failure strain of different matrices.

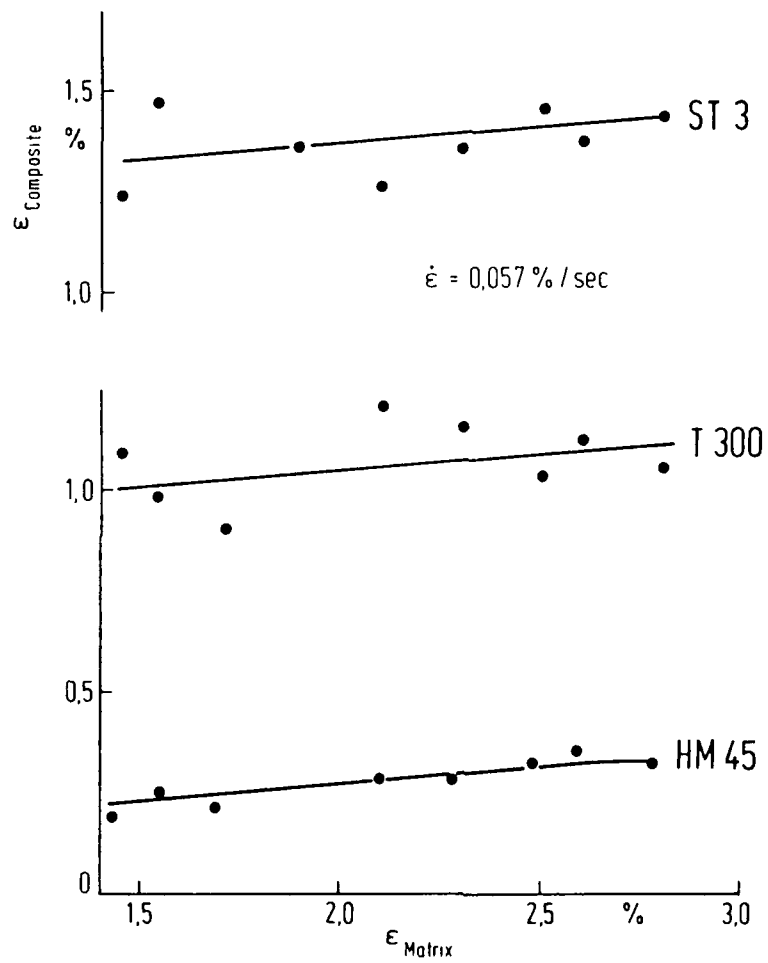
Fig. 11.12 Failure strain of CFRP-rings at a strain rate of 0.057 %/sec vs. failure strain of different matrices.

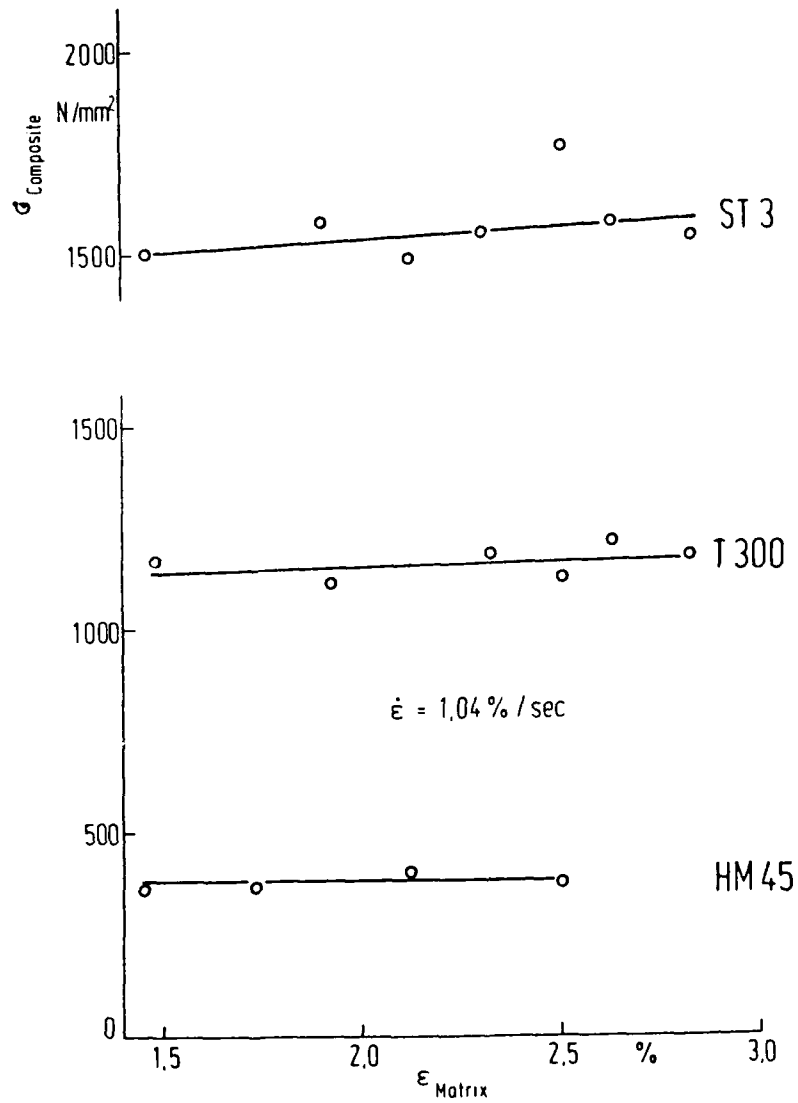
Fig. 11.13 Failure stress of CFRP-rings with a strain rate of 1,04 %/sec vs. failure strain of different matrices.

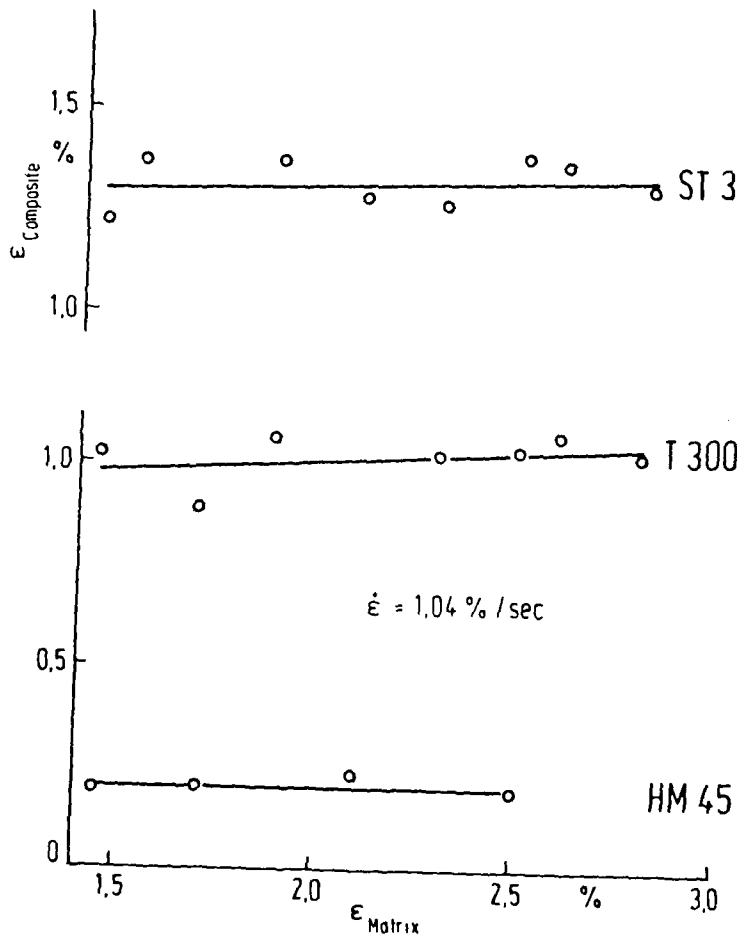
Fig. 11.14 Failure strain of CFRP-rings with a strain rate of 1,04 %/sec vs. failure strain of different matrices.

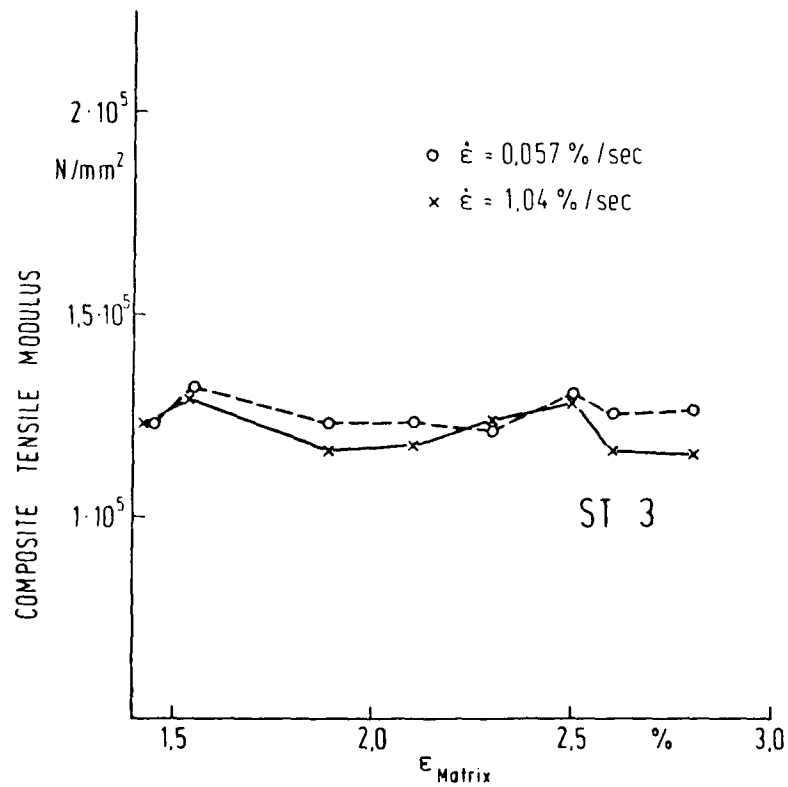
Fig. 11.15 Tensile modulus of CFRP-rings vs. failure strain of different matrices.

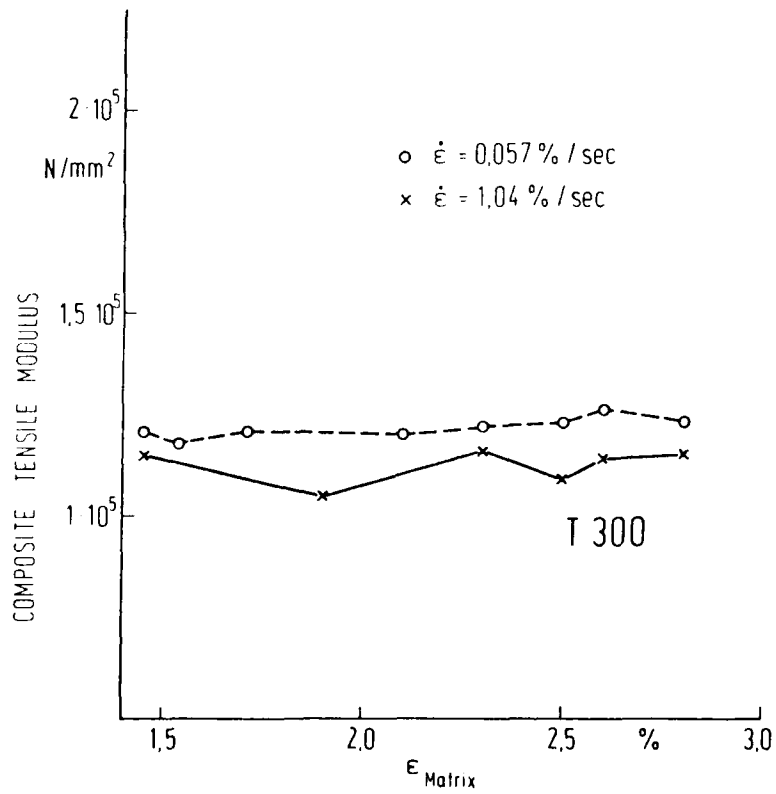
Fig. 11.16 Tensile modulus of CFRP-rings vs. failure strain of different matrices.

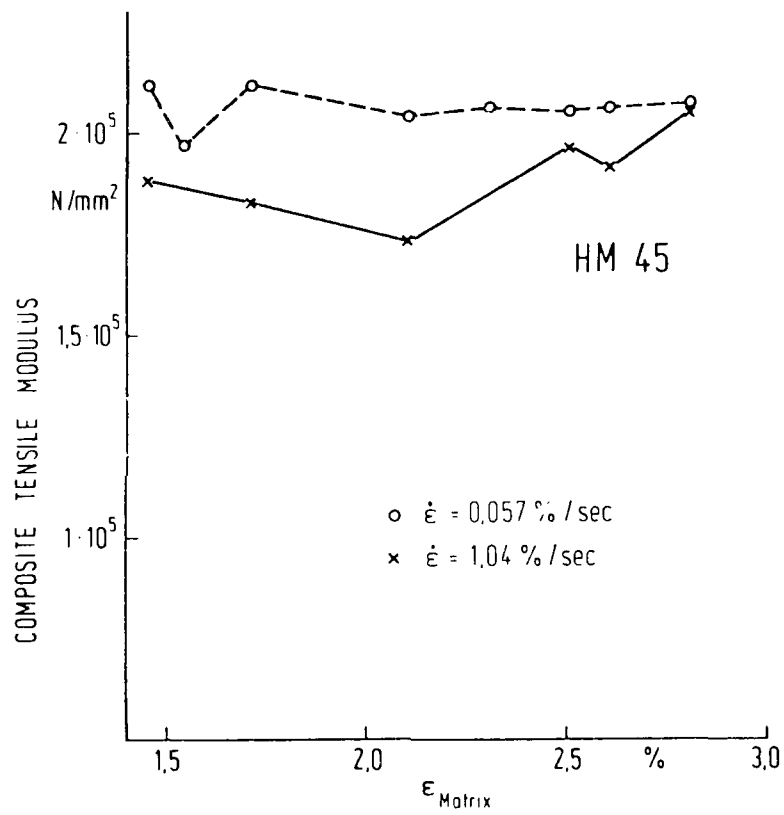
Fig. 11.17 Tensile modulus of CFRP-rings vs. failure strain of different matrices.

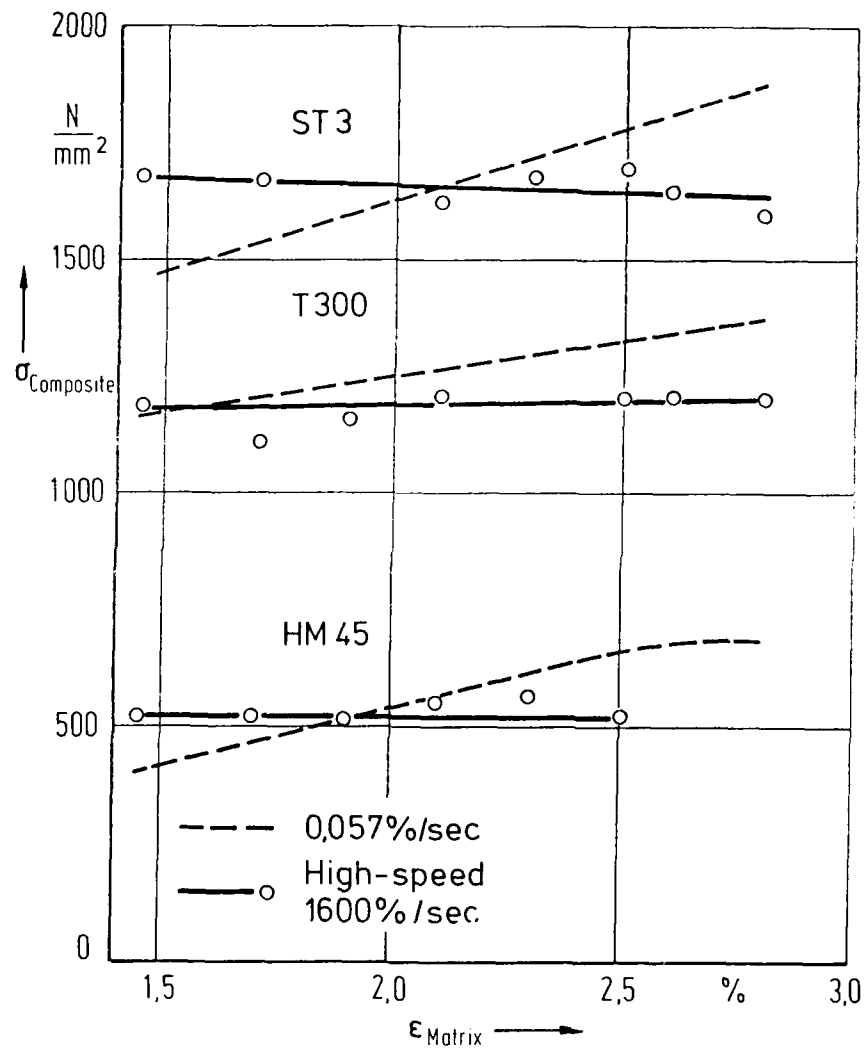
Fig.11.18 Failure stress at high and low speed loading of the variety of ring specimens.

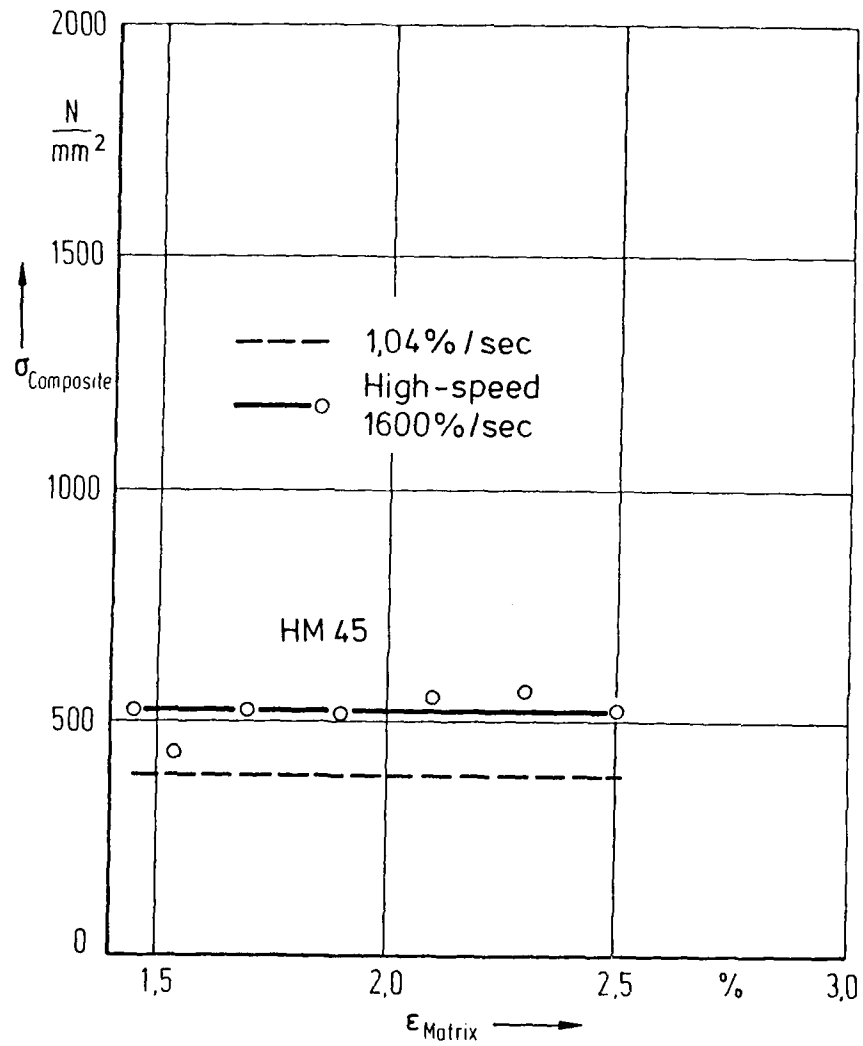
Fig.11.19 Failure stress of HM 45 ring specimens at strain rates of 1600 %/sec and 1,04 %/sec.
(average of two tests at high strain rate)

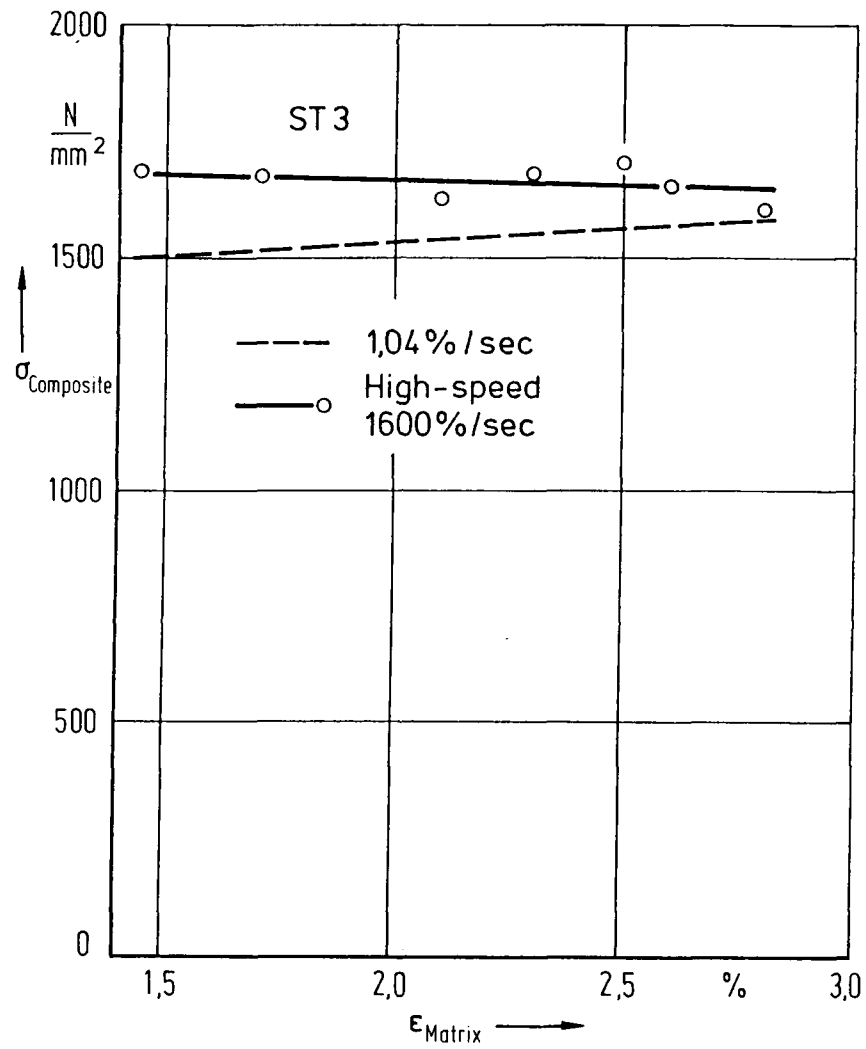
Fig.11.20 Failure stress of ST 3 ring specimens at strain rates of 1600 %/sec and 1,04 %/sec.
(average of two tests at high strain rate)

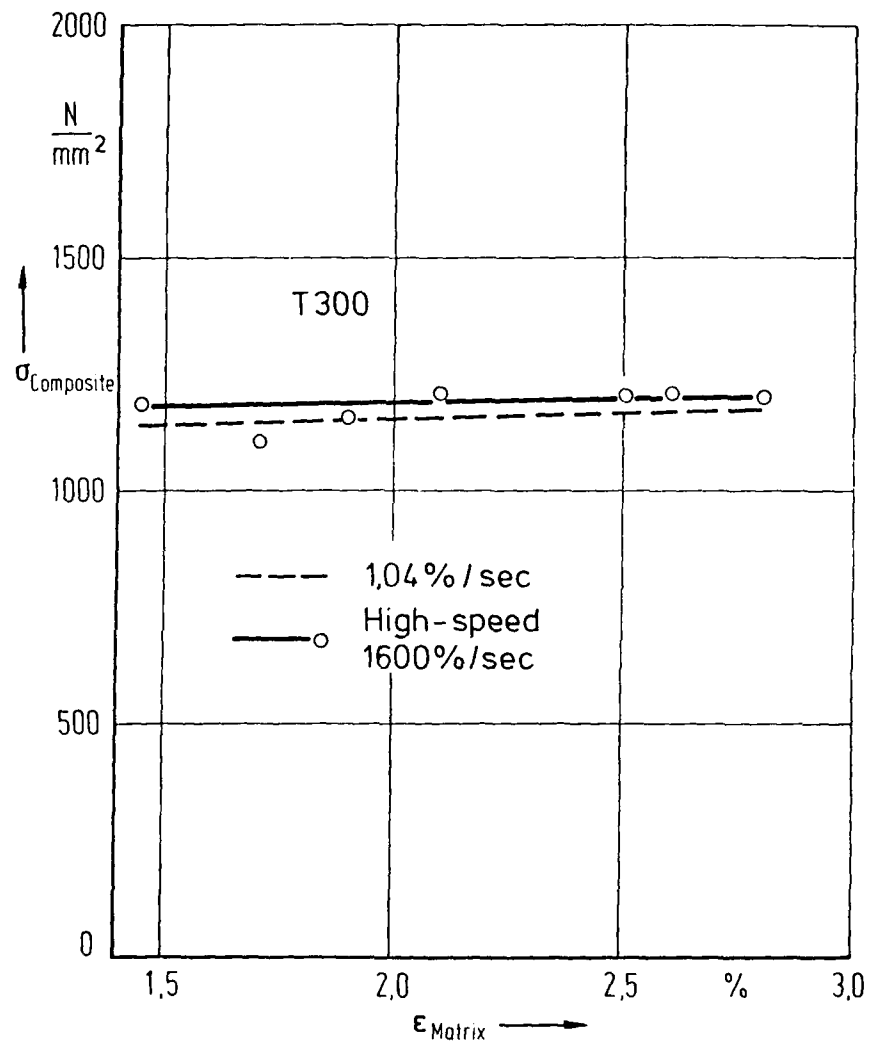
Fig.11.21 Failure stress of T 300 ring specimens at strain rates of 1600 %/sec and 1,04 %/sec.
(average of two tests at high strain rate)
